# Manhole Inspection Summary

Manhole # S37GG\_022MH

Insp Date: **3/21/07 11:50 AM**

**Location** Address: **1308 HOMEWOOD AVE**

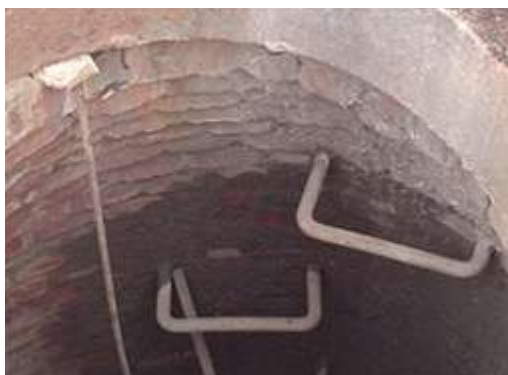
Defect

Channel debris.

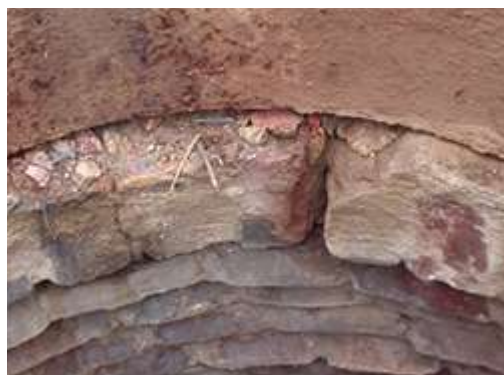
Defect

Frame leaks. Adjustment deterioration and infiltration. Corbel infiltration.

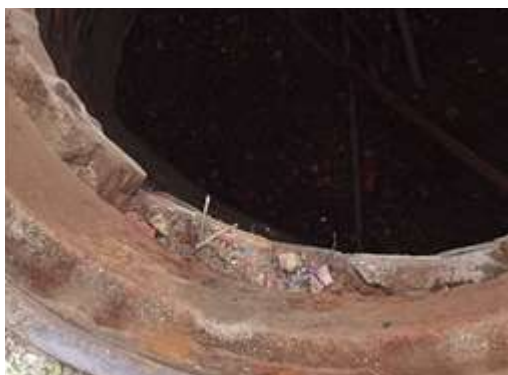
Defect

Frame leaks. Frame offset. Adjustment deterioration, loose brick and infiltration.

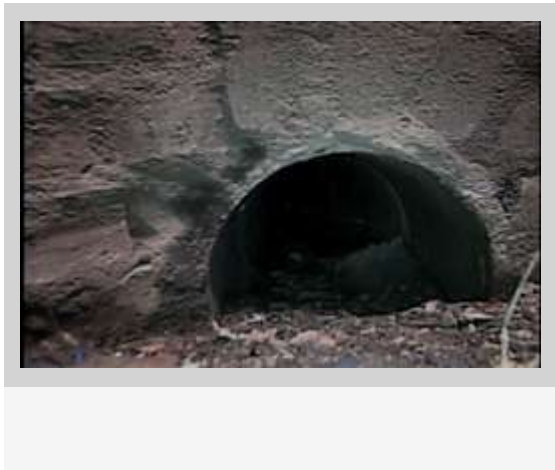
8 in. Circular Gravity Sewer  
Pipe Out @ 12 O'Clock

Frame leaks. Frame offset. Adjustment deterioration, loose brick and infiltration.

Deposits: ☐ None ☒ **Mud** ☐ Sludge ☒ **Debris** ☐ Grease

Silt Depth: **2** (in.) Deposits Extent: **Light**

Infiltration: **Evidence** Pipe Seal Cond: **Unknown**
